Dissertation for Doctoral (PhD) Degree

University of Sopron

**THE EXAMINATION OF WOODEN PILES OF LAKE-BUILDINGS**

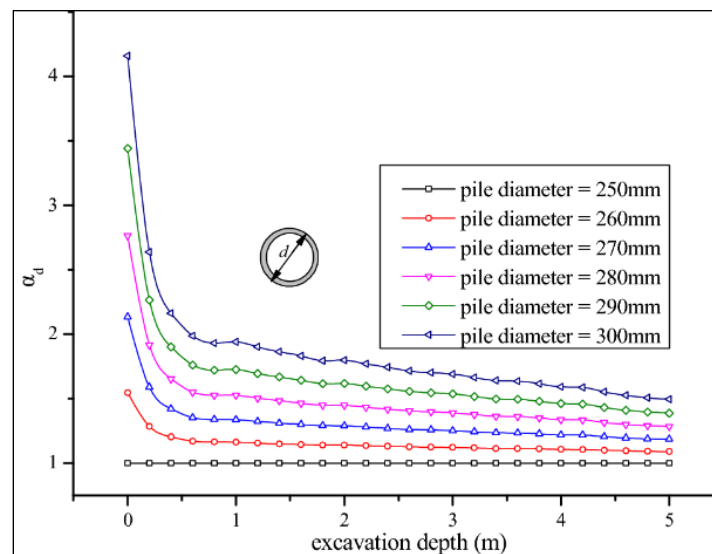
Pile diameter substantially affects buckling resistance by influencing the moment of inertia of the cross-section. Larger diameters increase flexural stiffness, thereby elevating the critical buckling load. For instance, Shan et al. (2022) demonstrated that, at a constant excavation depth of 1 m, increasing the pile diameter from 250 mm to 300 mm increased the critical top load by approximately 94% (Fig1.2). This relationship is well supported by multiple studies (J. Liu et al., 2020; R. Zhang et al., 2021a), reinforcing the importance of cross-sectional size and shape on pile stability.

Figure 1. 2 Influence of pile diameter on the critical load at different excavation depths (Shan et al., 2022).

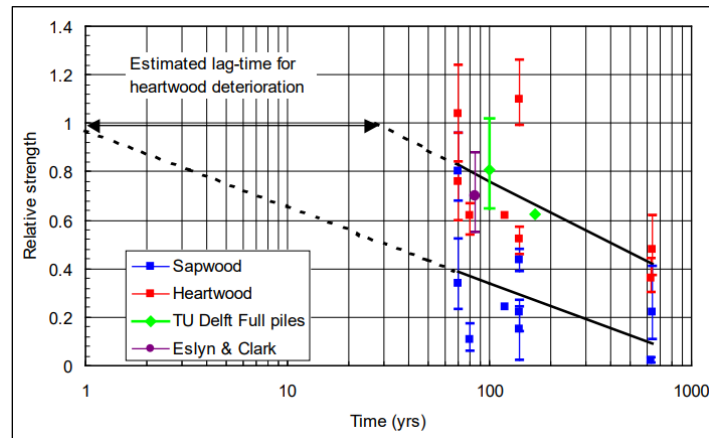
In addition, Sapwood degrades relatively quickly upon exposure, while heartwood deterioration is delayed, with decay onset estimated around 30 years post-submersion (Giuliana Zelada-Tumialan, 2014) (Fig. 1.7). Bacterial decay progression tends to slow significantly once the decay front reaches heartwood, suggesting a natural limit to cross-sectional degradation, allowing residual heartwood to provide structural support over extended periods depending on mechanical loading (Wang et al., 2008).

**Figure 1. 7** Deterioration of sap and heartwood as a function of age deterioration (Giuliana Zelada-Tumialan, 2014).

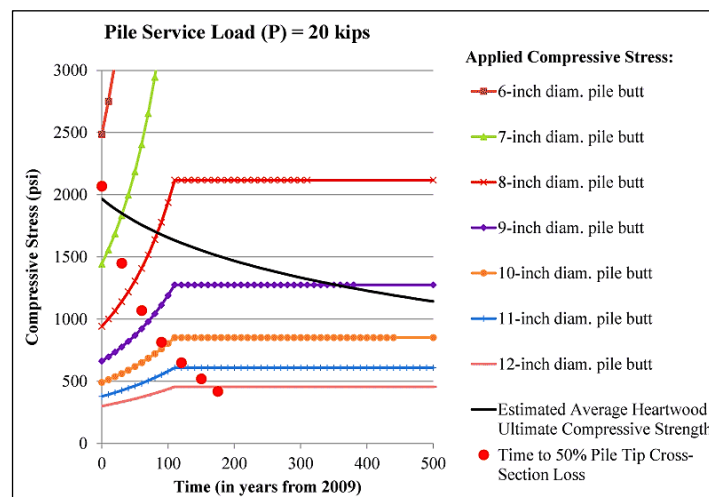
Sustained loads exceeding 55% of short-term strength induce creep deformation and potential failure, especially in sapwood-rich sections. However, heartwood's dominant structural role (>90% load bearing) mitigates creep risks (Holzer et al., 1989; P.Morlier, 1994).

**Figure 1. 8** Sample plots of applied compressive stress and estimated heartwood compressive strength vs. time (Giuliana Zelada-Tumialan, 2014).

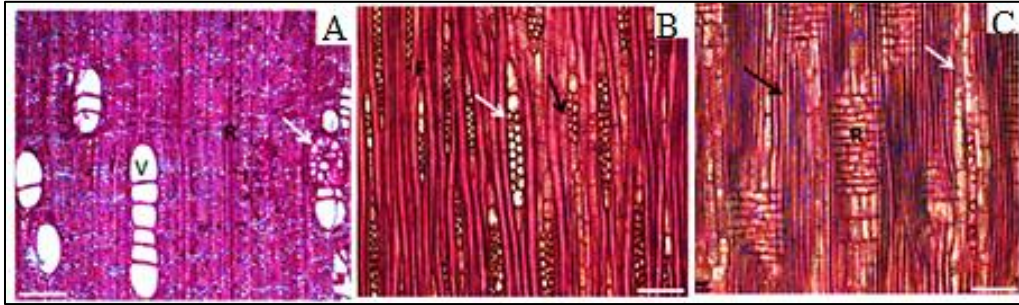
**Figure 1.11** The higher the wood density is, the smaller the number of voids in the wood is and vice versa (A, C) Cross-sections of the *Hevea brasiliensis* wood. Scale bars:100  $\mu\text{m}$  (Faria et al., 2021).

Compressive strength is directly proportional to wood density, as denser woods possess a more compact fiber structure with fewer voids or cavities, minimizing stress concentrations and crack propagation (Fig. 1.11). For example, *Red Oak*—a high-density hardwood—has a tip-end crushing strength nearly double that of lower-density *Southern Pine* (3,460 psi and 1,820 psi, respectively) (Thomas Lee Wilkinson, 1968). Increased density also contributes to improved dimensional stability (L. He et al., 2022; Sargent, 2022).

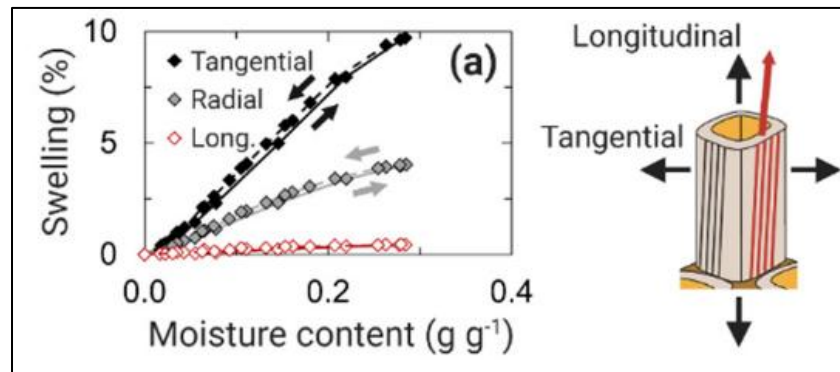
2017). Significant swelling occurs once MC exceeds 10–15%, affecting wood microfibril bundles (Paajanen et al., 2022).

**Figure 1.13** Effect of Moisture Content on Swelling in Wood's Primary Axes (Thybring et al., 2022).

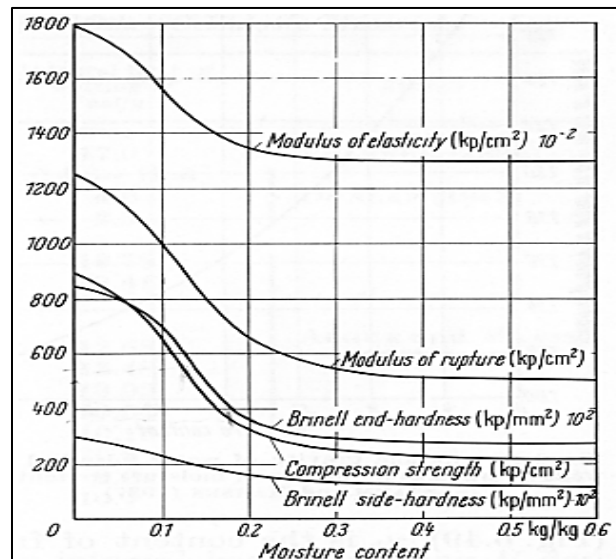
The modulus of elasticity (MOE), which measures stiffness, decreases with rising MC, with reductions up to 16% when MC increases from 12% to above FSP (Dietsch et al., 2015; Kherais et al., 2024) (Fig. 1.15).

Figure 1. 15 Influence of moisture content on selected wood properties (Dietsch et al., 2015).

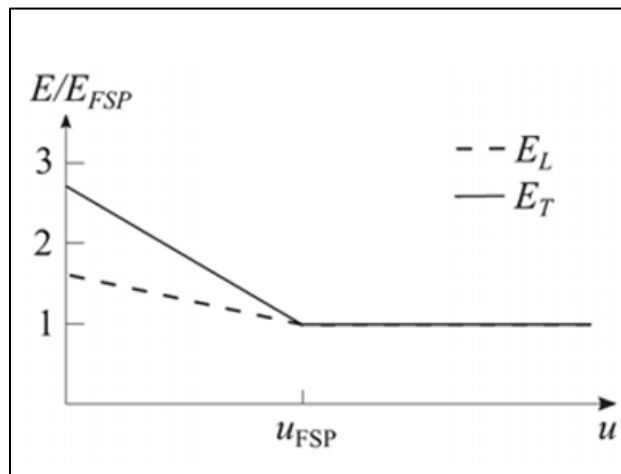
Below the fiber saturation point (FSP) ( $\sim 30\%$ ), MOE may initially increase slightly due to water's plasticizing effect on the cellulose matrix, enhancing internal hydrogen bonding and stiffness. However, once MC surpasses FSP, excessive water weakens fiber-to-fiber bonds, leading to a significant decline in MOE. Research by Soares et al. (2021) indicates that increasing MC from 12% to over 30% can reduce MOE by up to 16% in some wood species. Further Kherais et al.(2024) found that moisture saturation reduces MOE by 15–20%, while higher MC levels (12%, 15%, 18%) result in a 10–25% decrease in MOE.

Figure 1. 16 Effect of Moisture Content on Elastic Moduli Parallel, Perpendicular to the Grain, Normalized to FSP (Sabina, 2019).

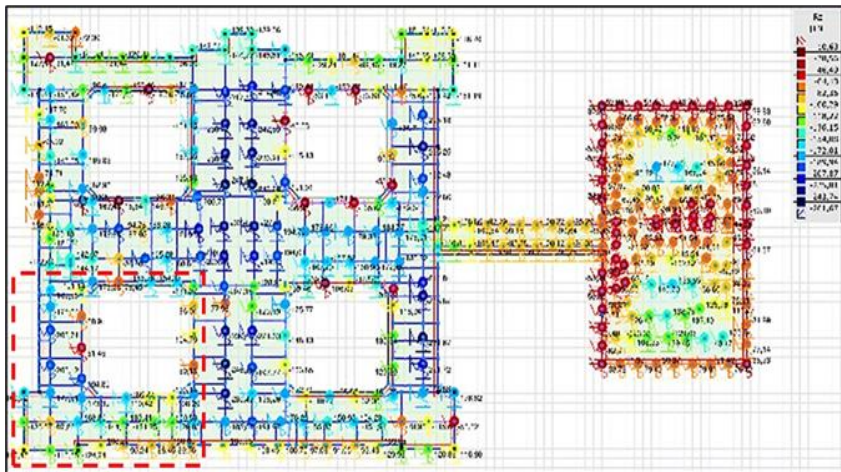
**Figure 2.1** Structural modeling of submerged wooden piles in Hévíz Center, emphasizing 40 piles under evaluation (Author).

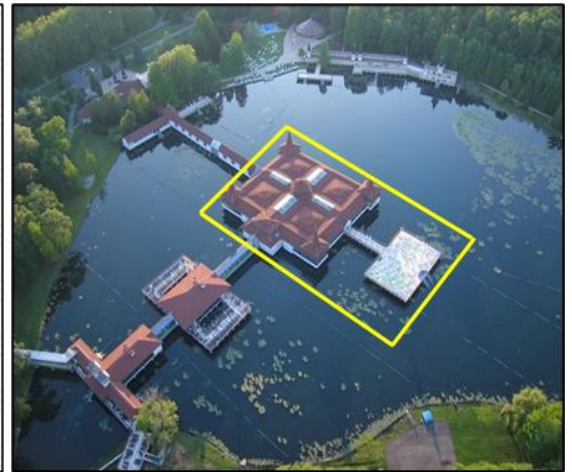
**Figure 2.2** Hévíz Lake Building – Tested Structural Section (Author).

This experimental investigation was conducted at Hévíz Lake, Hungary, where 40 submerged wooden piles supporting lake-based structures were selected from an initial dataset of 400 piles (Figs. 2.1–2.2). These heritage elements are subject to unique environmental conditions due to prolonged immersion in thermal waters. Piles were selected based on structural significance, accessibility, and visible signs of deterioration or historical damage.

The majority of the piles were composed of timber species such as spruce, larch, and oak, with circular cross-sections between 20–29 cm in diameter. However, the specific research samples analyzed in this study were identified as spruce with a uniform diameter of 20 cm.

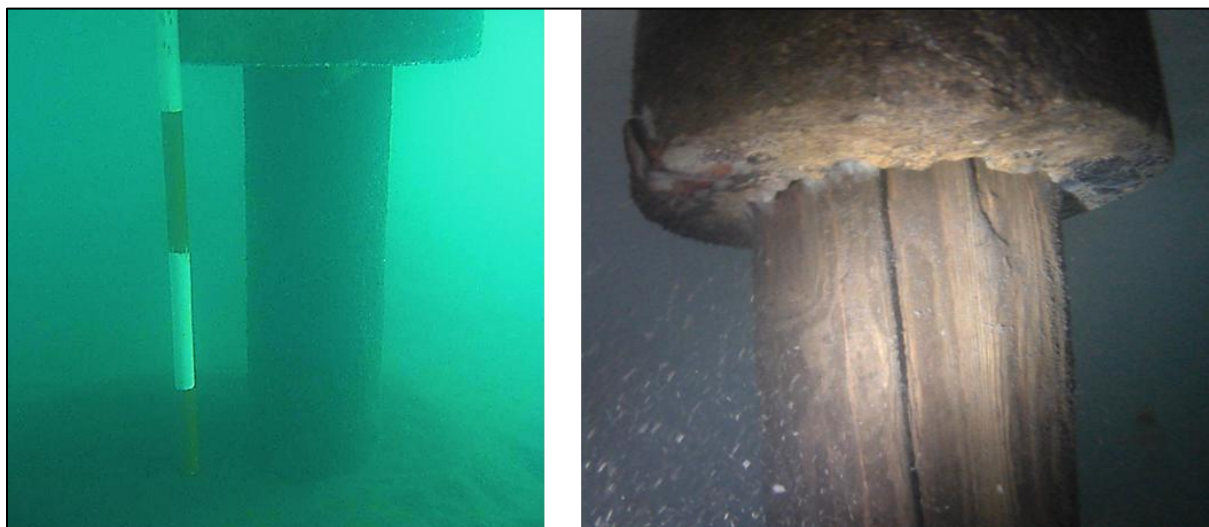
**Figure 2.3** A wooden pile submerged in Hévíz lake (Author).

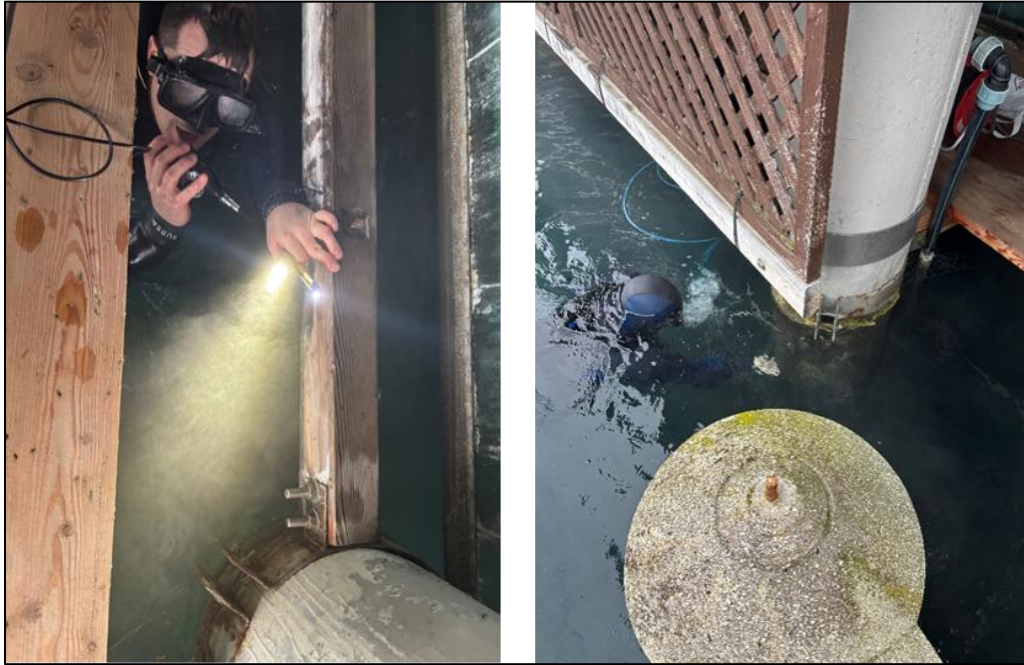
**Figure 2.5** In situ diver-assisted sound velocity measurement at Hévíz Lake (Author).

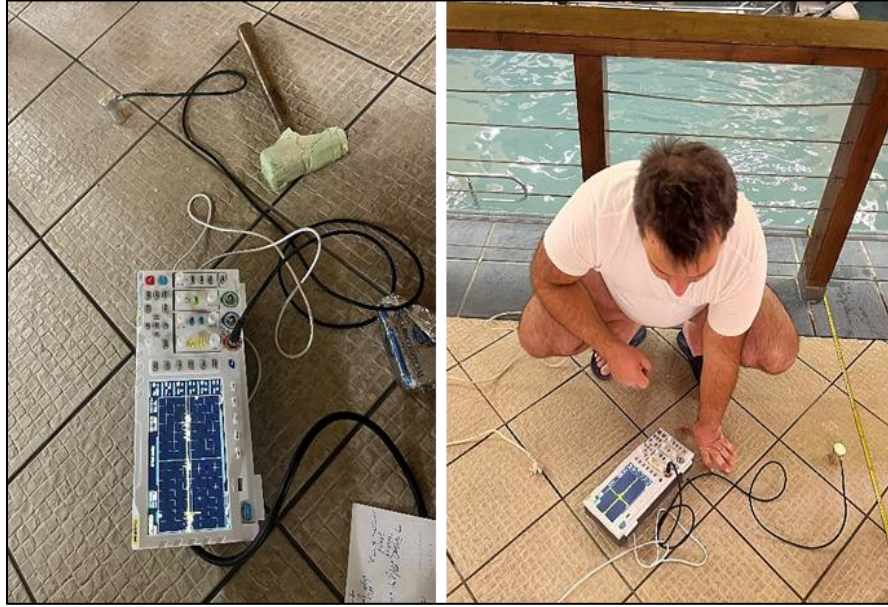
**Figure 2.7** Oscilloscope-Based Measurement and Signal Detection Setup for Pile Vibration Analysis (Author).

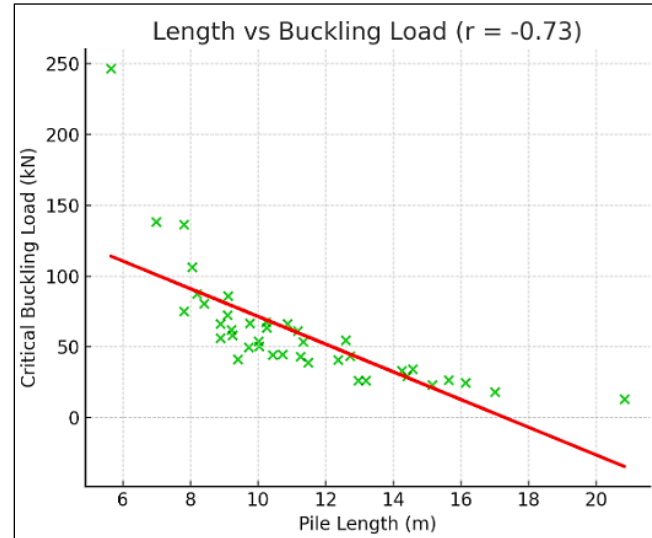
**Figure 3. 6** The relationship between pile length and critical buckling load (Author).

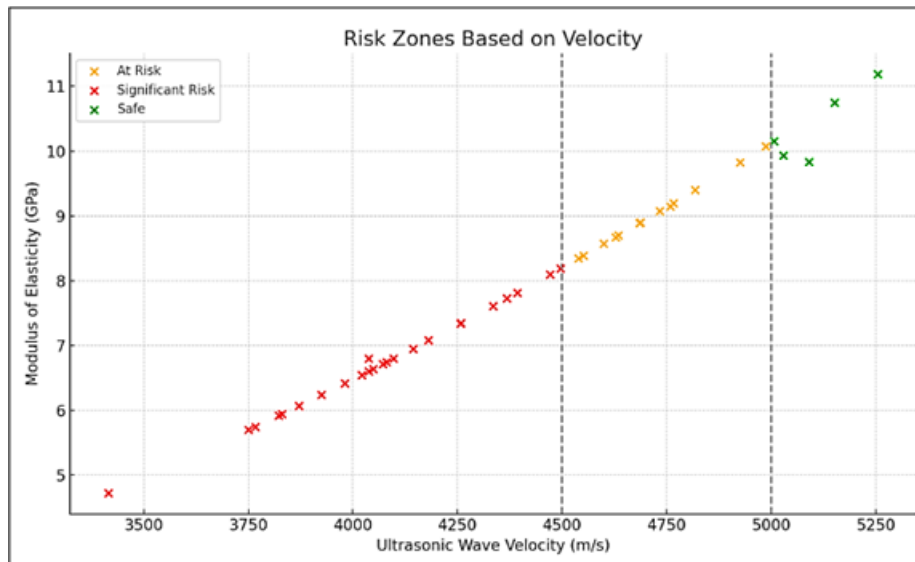
Figure 3. 11 Ultrasonic wave velocity–MOE scatter plot with velocity-based risk classifications (Author).

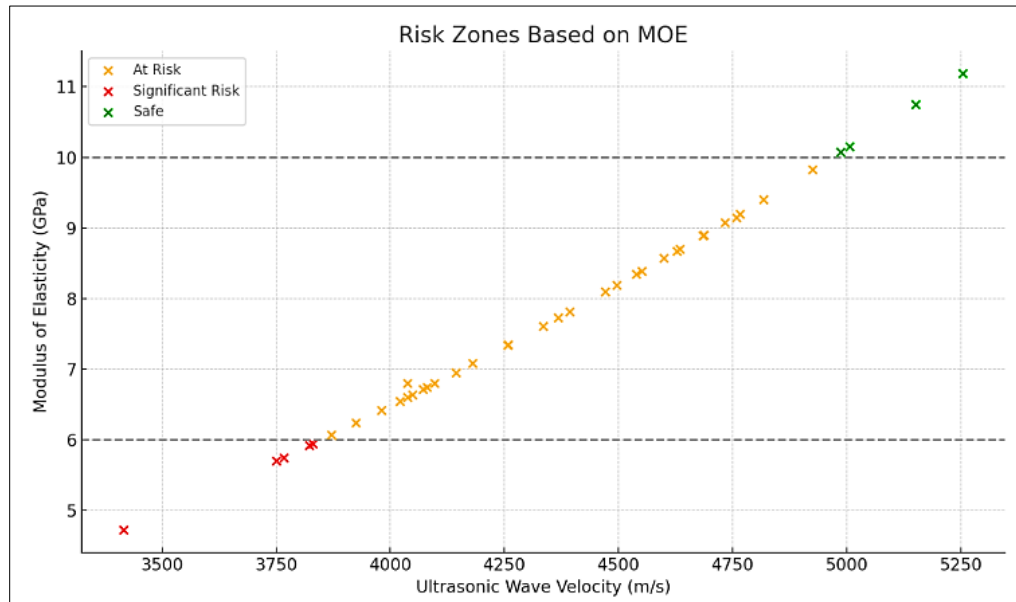
**Figure 3. 12** Ultrasonic velocity–MOE scatter plot with MOE-based risk classifications (Author).

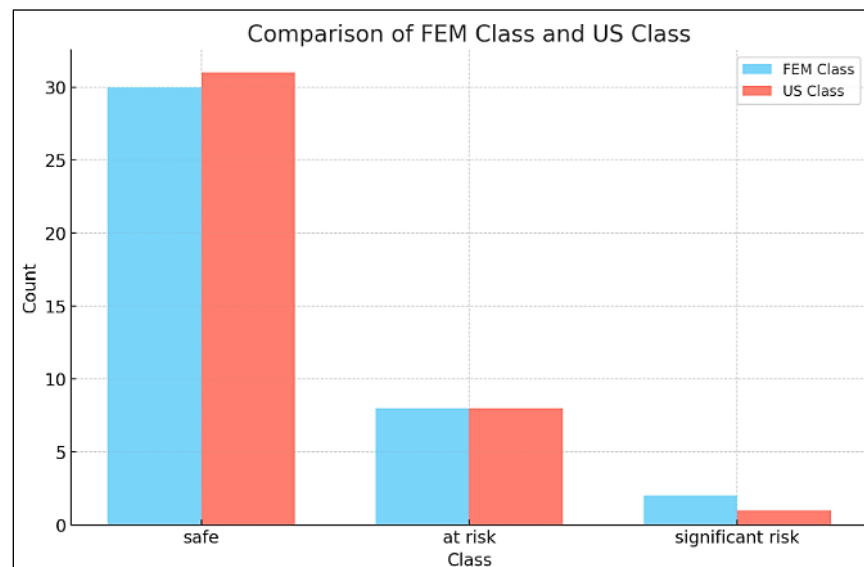
**Figure 3. 31** Comparison of pile risk classifications using FEM and ultrasonic-informed Euler methods (Author).
